## Heritage Citation

**Bank of New South Wales (former)**

This bank building, demonstrating elements of the Interwar Stripped Classical style, was completed in 1921 for the Bank of New South Wales. Constructed at a time when South Brisbane was experiencing a period of increasing prosperity, the bank is significant as an example of 1920s bank architecture and for its aesthetic qualities.

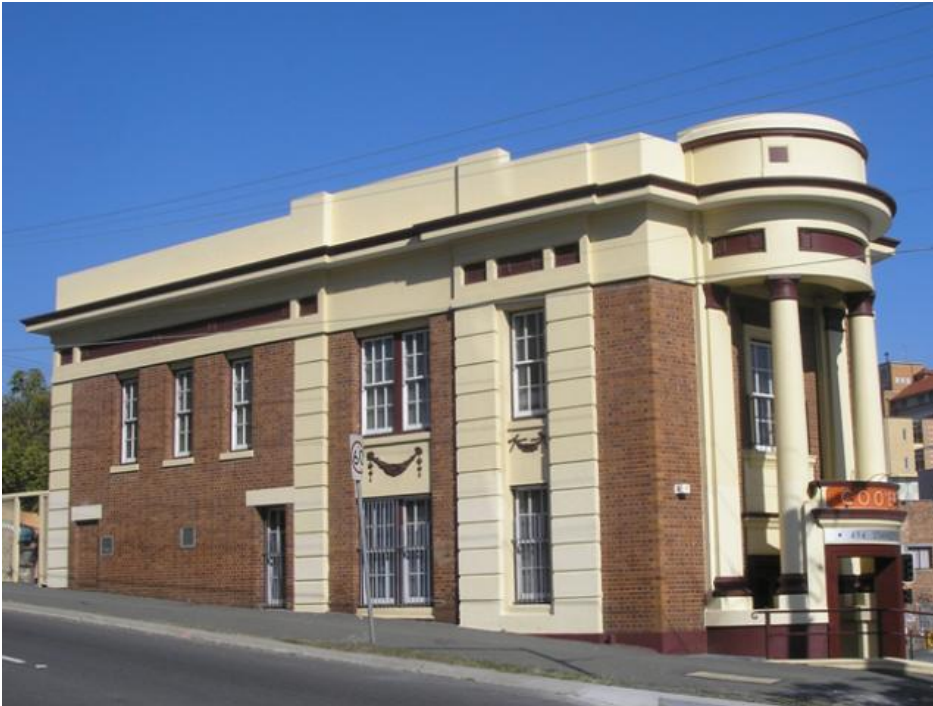
This two storey building is located on a prominent site at an acute corner between Stanley and Vulture Streets. The building's form is greatly influenced by its location, with its use of the truncated corner as an entry. This corner treatment is emphasised for the use of a cylindrical element, which appears as part of the stepped plinth over the entry doors, and is then reflected in the frieze and parapet directly above it. This section of the parapet appears to gain support from a pair of tapering columns one on either side of the entry doors.
