## Heritage Citation

### A.E. Griffiths Service Station (former)

#### Key details

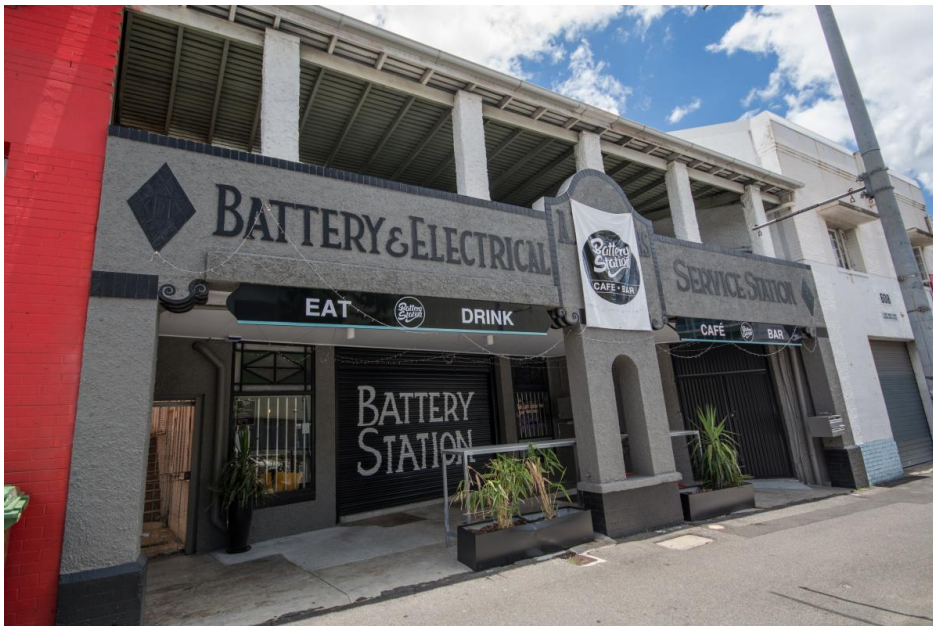
The building is of two storeyed masonry construction with a painted brick base, pebble dash stucco surface to the lower floor walls and upper floor columns, and smooth render to the upper floor walls. The right hand side of the façade contains a ground floor pedestrian door with a bracketed concrete hood, and a large combined door and shopfront window, which may not be original. The upper floor has two casement window openings with cantilevered concrete hoods and a masonry parapet with a corbelled stringcourse and central vertical art deco moulded decoration.

The left hand side of the façade contains an open ground floor porch with flanking columns and a central double column with a semi circular arched division, with decorative moulded column brackets and brick-on-end capping to the underside of the first floor balcony. The balcony balustrade is solid masonry with a straight brick on edge capping except to the central section where it projects up to a curved top with a brick edging accentuating the central double column below. The balustrade contains the building's name in decorative lettering, and diamond motifs in raised smooth render against a pebble-dash background.

Five square masonry columns above the balustrade are equally spaced about the centre line, with the end columns kept in from the end of the balustrade. The columns have a brick capping, and support a longitudinal verandah beam, which in turn supports closely spaced rafters with decoratively tapered ends. Low pitched corrugated iron roof sheeting on battens covers the open first floor balcony, and a scalloped vertical batten frieze is suspended below the verandah plate between the back edges of the columns, and the end returns.

The use of pebble-dash stucco round headed arches, and moulded column capitals gives the business portion of the building a distinctive Spanish Mission or Mediterranean appearance, while the other residential half has a more subdued art-deco style.
