Heritage Citation

Wagner Farmhouse

Addresses	At 95 Hows Road, Nundah, Queensland 4012
Type of place	Farm house
Period	Victorian 1860-1890
Lot plan	L1_RP96894
Geolocation	-27.407498 153.066220
Key dates	Significant Development — Circa 1888 Local Heritage Place Since — 28 February 2020 Date of Citation — April 2018
People/associations	Johann Gottfried Wagner
Criterion for listing	(A) Historical; (H) Historical association

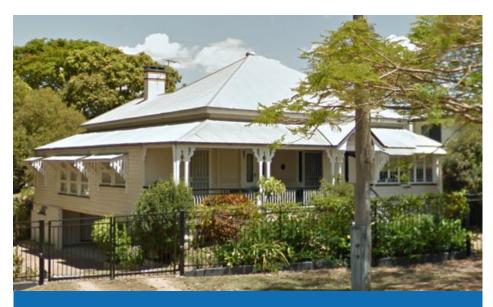
Wagner Farmhouse is a timber and tin colonial residence located in a residential street of Nundah. The house features a pyramidal hipped roof, separate skillion verandah roof, painted brick chimney, ornate timber detailing and gabled frontispiece over the verandah entry.

Wagner Farmhouse has an original square core with kitchen to the rear and wrap around verandahs to the north and east. The roof core is pyramidal in shape, with a hipped roof to the rear kitchen wing, and separate skillion roof to the verandahs. The eaves are narrow throughout. Each of the roofs is clad in later sheet metal. An early rear verandah may have been removed to allow for the low skillion roofed living room addition at the rear. A lower level hipped roof also to the rear, covers a paved outdoor entertainment area. A painted brick chimney with contrast banding is located over the rear kitchen wing.

The external walls are clad in timber chamferboard with vertical-jointed timber and exposed framing to the front verandah. There are timber-framed windows throughout including original double hung, and later clear glazed casements and hoppers to later works. There are separate timber and tin window awnings with battened

brackets to all external windows. The front verandah features double chamfered posts with ornate timber brackets, a three-rail dowel timber balustrade, ornate lattice timber double gates and painted timber decking. The heavily panelled timber entrance door with decorative leadlight sidelights and fanlights has similar leadlight French doors adjacent. The verandah is accessed via a short run of timber stairs with gabled frontispiece with decorative bargeboards and filigree infill over.

Open concrete breezeblocks enclose the front subfloor area, between the square concrete stumps. The lower floor additions include both solid blockwork infill and retaining with timber chamferboard to the rear and portions of the western elevation.

The residence appears well maintained and in excellent condition. There have been some alterations and additions to the original residence including enclosing underneath to provide car accommodation, storage, utility, and additional accommodation. There has also been a partial enclosure of the verandah at the front, as well as the additional skillion roofed family room to the rear, connecting to the lower floor. A hipped roof covered terrace to the rear has also been added.
